Manhole Inspection Form

M1-3-3-2

Date: 6-28-17
Address: 26323 Rosebarn
R.T. = 12.05'
D = 48"
Map: 78

Manhole Number: M1-3-3-2
Community: Chesterfield
Inspector Initials: CAD / RBC

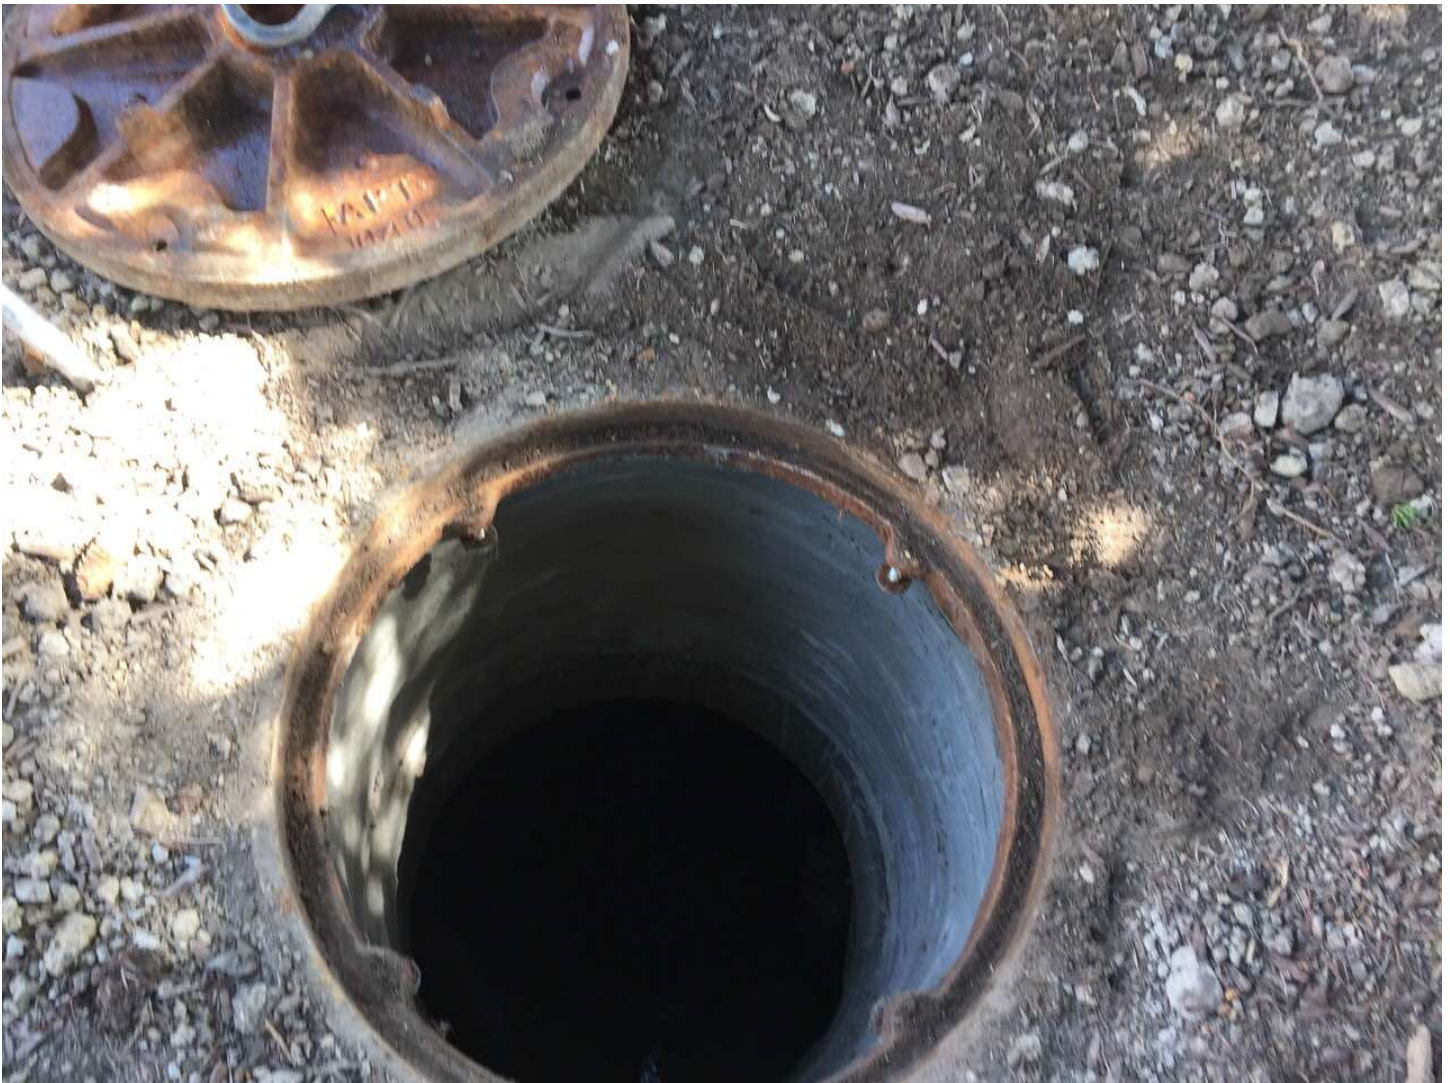
Manhole Number	M1-3-3-2	Historic Manhole Number	Rosebriar 2
Year Installed	1992	Structure Type	Sanitary Manhole
Street	Rosebriar	Address	26323
Elevation	591.838	Weather	Sunny
Temperature	65°	Ground Condition	Dry
Status	At Surface Grade	Location	Field
Pavment Condition	N/A	Traffic	No Traffic at Location
Inspector 1	Rbc	Inspector 2	Cad
Cover Type	EJ 1040APT	Number of Cover Holes	3 - 5
Catch Basin Cover	N/A	Cover Insert	No
Cover Gasket	Yes	Cover Grade	Cover is At Grade
Grade Dist	<null>	Cover Fit	Good Fit
Cover Condition	Good	Frame Condition	Good
Frame Offset	<null>	Frame Seal Condition	Good
Frame Seal Inflow	None	Frame Riser	No
Frame Riser Height	<null>	Frame Riser Material	<null>
Manhole Diameter	48	Manhole Depth	12.05
Chimney Depth	<null>	Chimney Construction	Block
Chimney Condition	Good	Chimney Inflow	None
Cone Shape	<null>	Cone Depth	<null>
Cone Construction	Precast	Cone Condition	Fair
Cone Inflow	Low	Cone Defect Location	Wall/Cone Joint

3 – Failure likely in 10 to 20 years
(Fair) Comments

Pipe 6 Flow	<null>	Pipe 6 Diameter	<null>
Pipe 6 Direction	<null>	Pipe 6 Depth	<null>
Pipe 6 Material	<null>	Pipe 6 Seal Condition	<null>
Pipe 6 Drop	<null>	Pipe 6 Comments	<null>
Recommendation 1	Vactor Clean	Recommendation 2	Seal Wall Joints
Recommendation 3	Point Pipes	Recommendation 4	<null>
Recommendation 5	<null>	Recommendation 6	<null>
