Manhole Inspection Form

M1-3-5-2

Manhole Number: M1-3-5-2
Community: Chesterfield
Inspector Initials: KMD / BRS

Date: 12/14/16
Address: 46685 Briarwood
R.T. = 9.85'
D = 46"
Map: S2

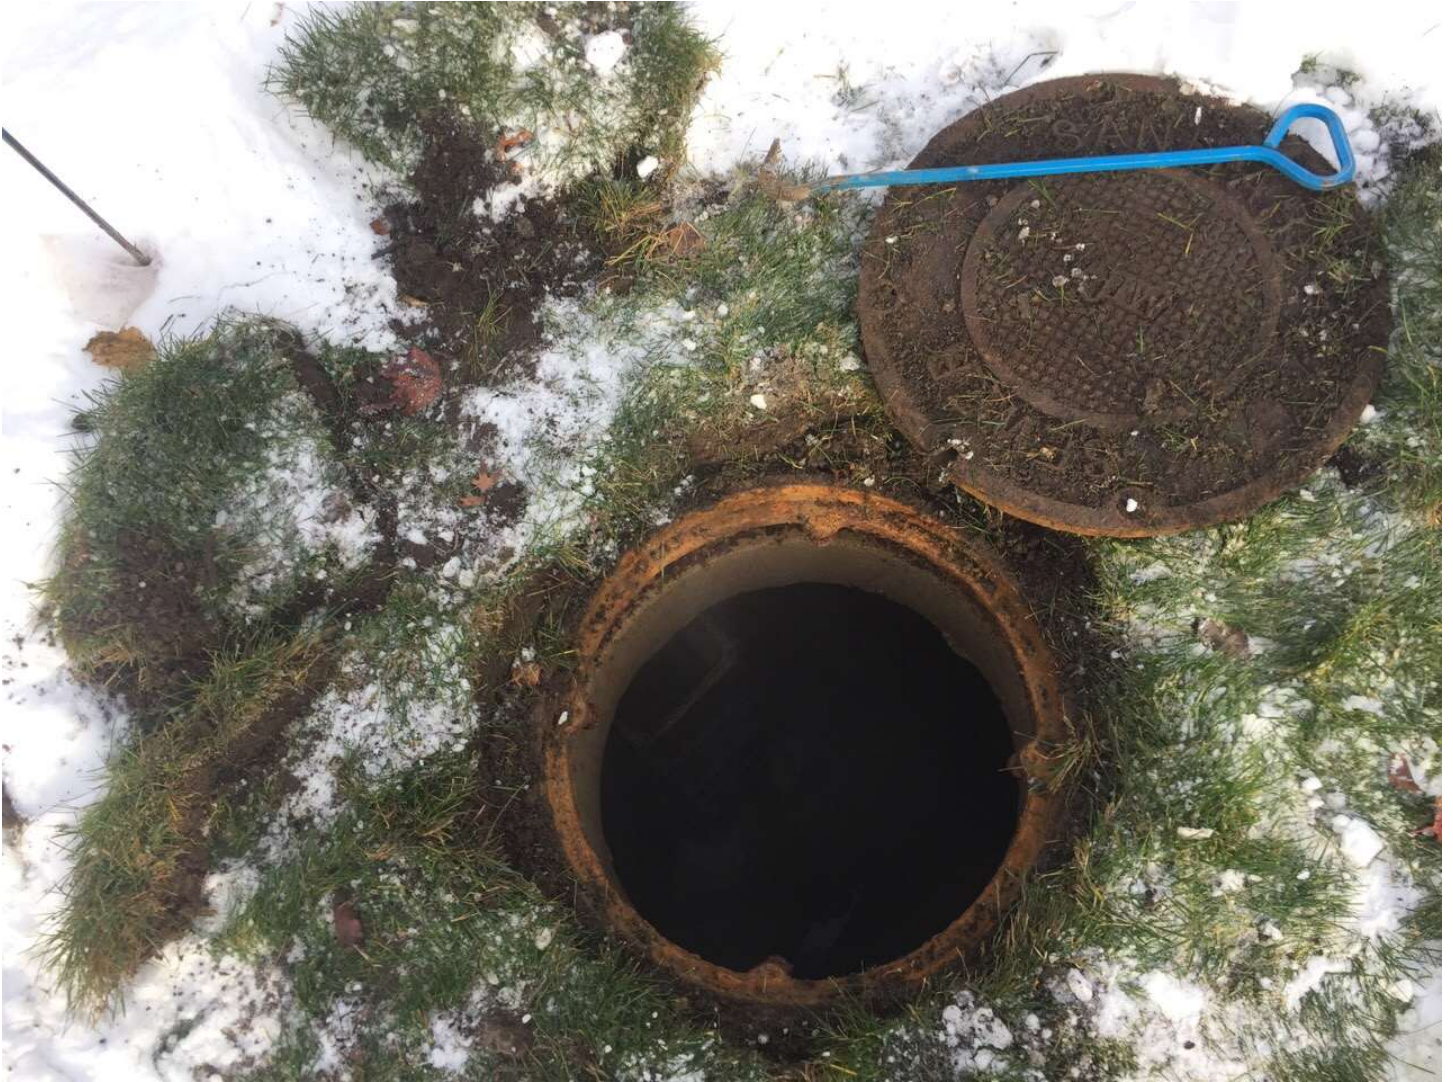
M1-3-5-2

Recommendation 7	<null>	Recommendation 8	<null>
Manhole Rating	2 – Failure unlikely in 20 years (Good)	Comments	Buried 1"
