Manhole Inspection Form

M1-5-3-3-8-5

Community: Chesterfield

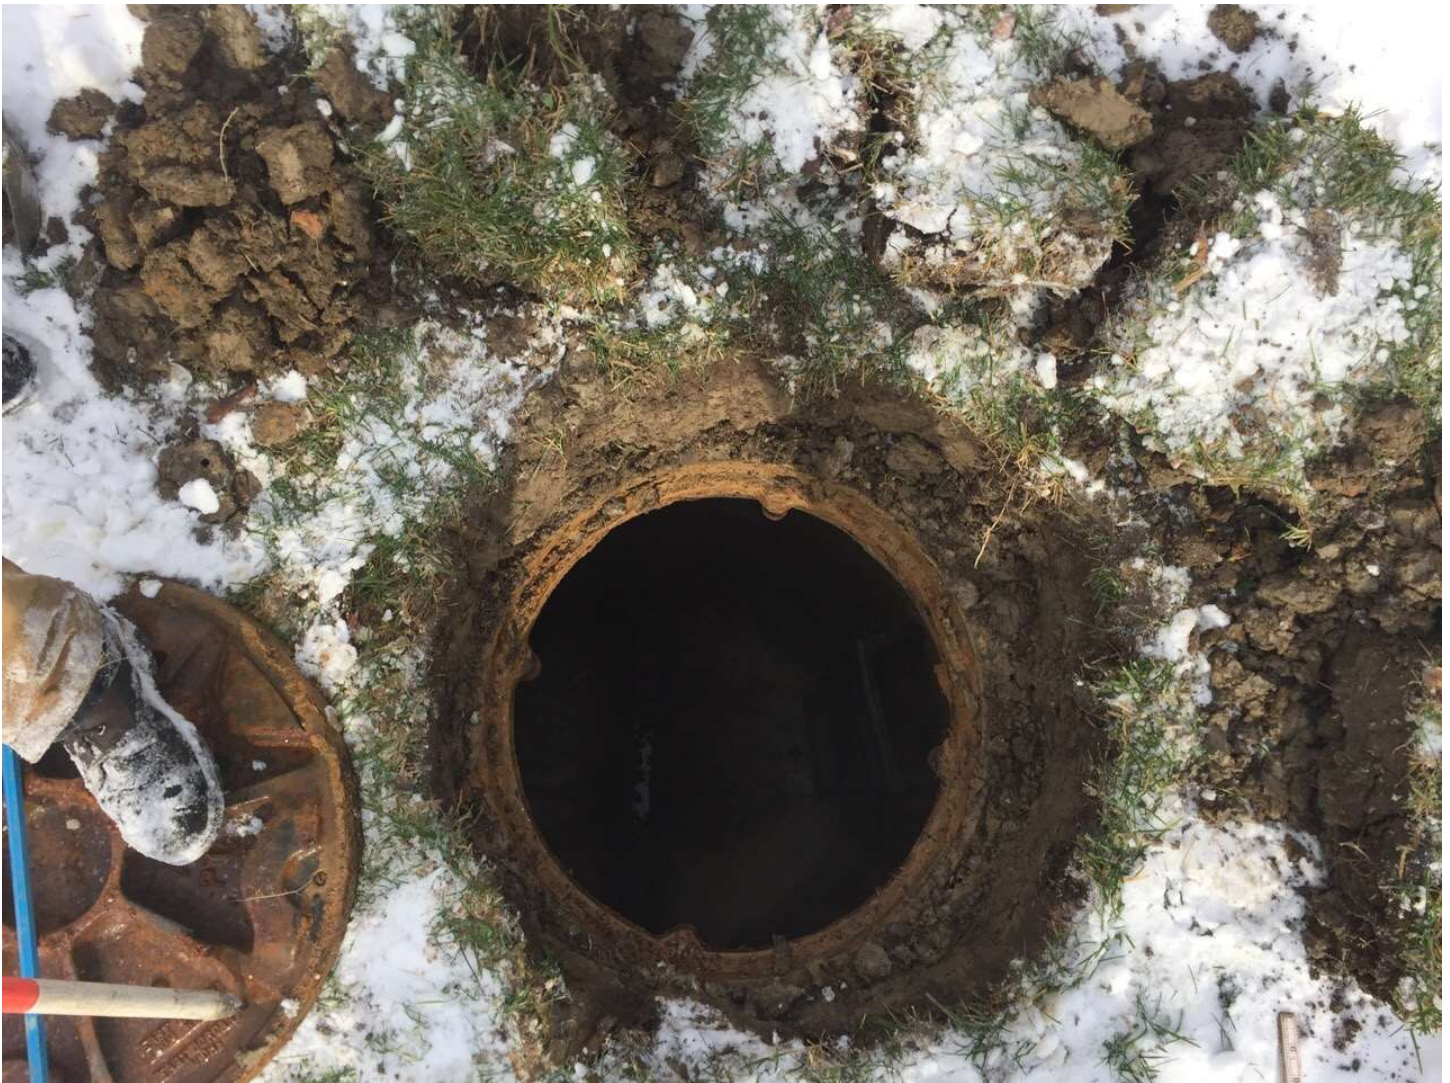
Recommendation 7	<null>	Recommendation 8	<null>
Manhole Rating	2 – Failure unlikely in 20 years (Good)	Comments	Buried 6"

Pipe 6 Flow	<null>	Pipe 6 Diameter	<null>
Pipe 6 Direction	<null>	Pipe 6 Depth	<null>
Pipe 6 Material	<null>	Pipe 6 Seal Condition	<null>
Pipe 6 Drop	<null>	Pipe 6 Comments	<null>
Recommendation 1	Raise	Recommendation 2	<null>
Recommendation 3	<null>	Recommendation 4	<null>
Recommendation 5	<null>	Recommendation 6	<null>
