Manhole Inspection Form

M1-5-3-3-13-1

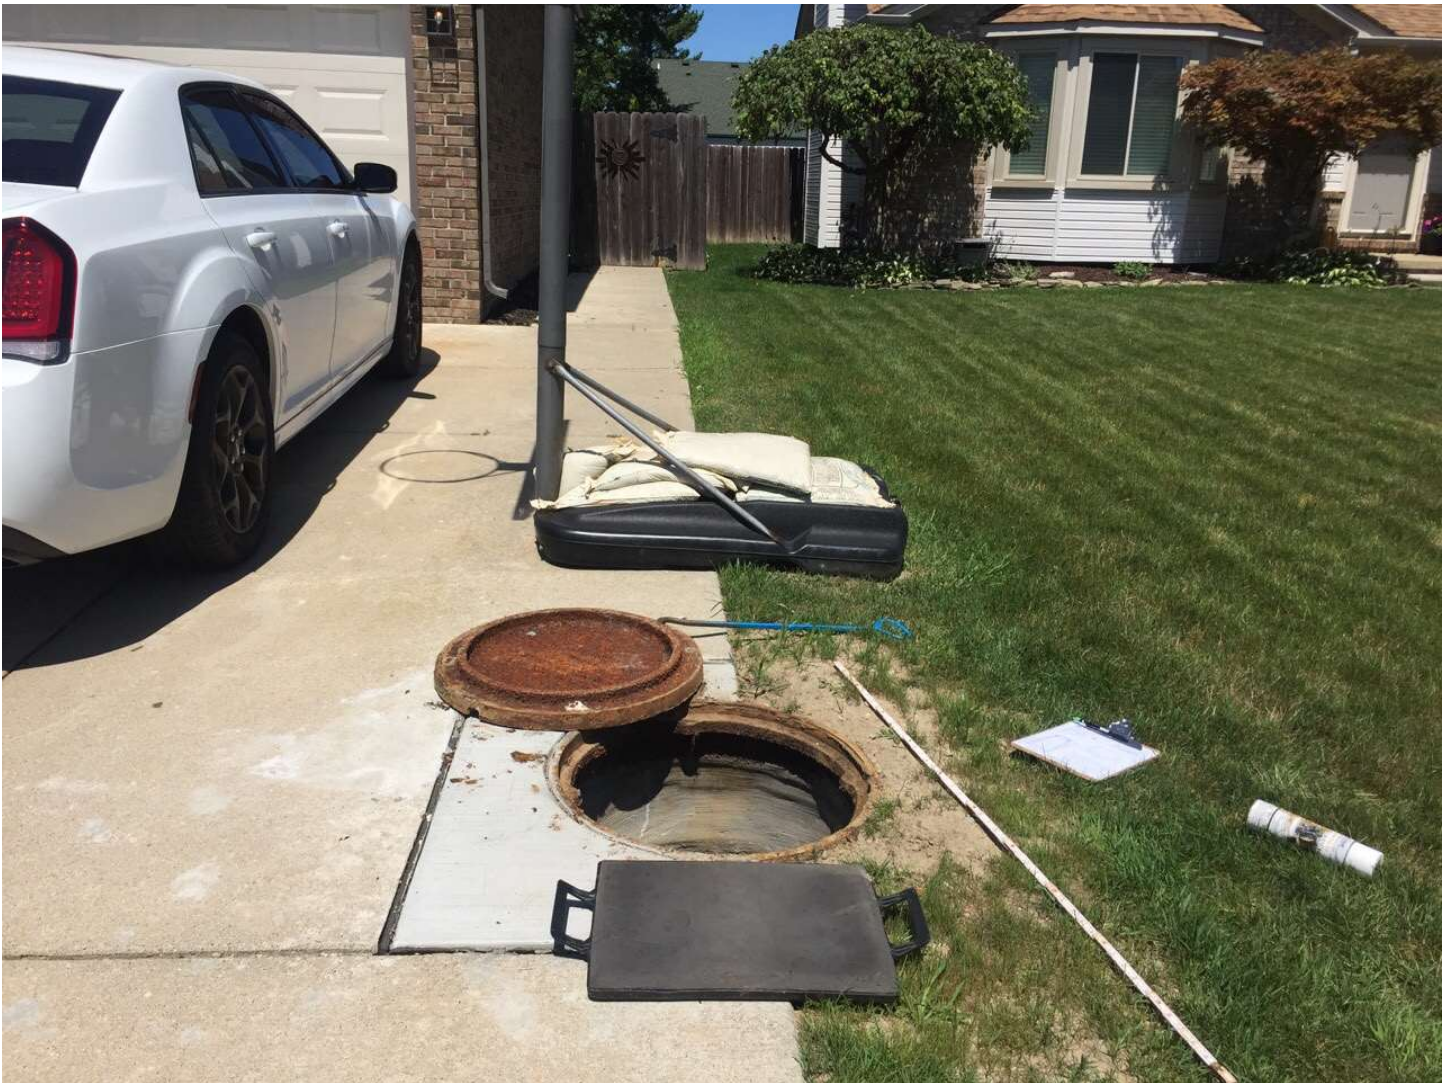
Manhole Number	M1-5-3-3-13-1	Historic Manhole Number	Lord 1
Year Installed	1993	Structure Type	Sanitary Manhole
Street	Lord	Address	25847
Elevation	591.782	Weather	Sunny
Temperature	75°	Ground Condition	Dry
Status	Not Found	Location	Driveway Concrete
Pavment Condition	Good	Traffic	Driveway
Inspector 1	Ac	Inspector 2	Rbc
Cover Type	ej1040apt	Number of Cover Holes	3 - 5
Catch Basin Cover	<null>	Cover Insert	No
Cover Gasket	No	Cover Grade	Cover is At Grade
Grade Dist	<null>	Cover Fit	Good Fit
Cover Condition	Cracked	Frame Condition	Fair
Frame Offset	<null>	Frame Seal Condition	Good
Frame Seal Inflow	None	Frame Riser	No
Frame Riser Height	<null>	Frame Riser Material	<null>
Manhole Diameter	48	Manhole Depth	17.2
Chimney Depth	1	Chimney Construction	Poured
Chimney Condition	Good	Chimney Inflow	None
Cone Shape	<null>	Cone Depth	36
Cone Construction	Precast	Cone Condition	Good
Cone Inflow	Low	Cone Defect Location	Cone Surface

Wall Construction	Precast	Wall Condition	Good
Wall Inflow	None	Wall Defect Location	N/A
Wall Defect Location 2	<null>	Wall Defect Location 3	<null>
Wall Defect Location 4	<null>	Wall Defect Location 5	<null>
Bench Construction	Poured	Bench Condition	Good
Bench Inflow	None	Channel Construction	Poured
Channel Condition	Good	Channel Inflow	None
Channel Hydraulics	Good	Channel Exposure	Fully

Recommendation 7	<null>	Recommendation 8	<null>
Manhole Rating	2 – Failure unlikely in 20 years (Good)	Comments	<null>

Pipe 6 Flow	<null>	Pipe 6 Diameter	<null>
Pipe 6 Direction	<null>	Pipe 6 Depth	<null>
Pipe 6 Material	<null>	Pipe 6 Seal Condition	<null>
Pipe 6 Drop	<null>	Pipe 6 Comments	<null>
Recommendation 1	Replace Cover	Recommendation 2	<null>
Recommendation 3	<null>	Recommendation 4	<null>
Recommendation 5	<null>	Recommendation 6	<null>

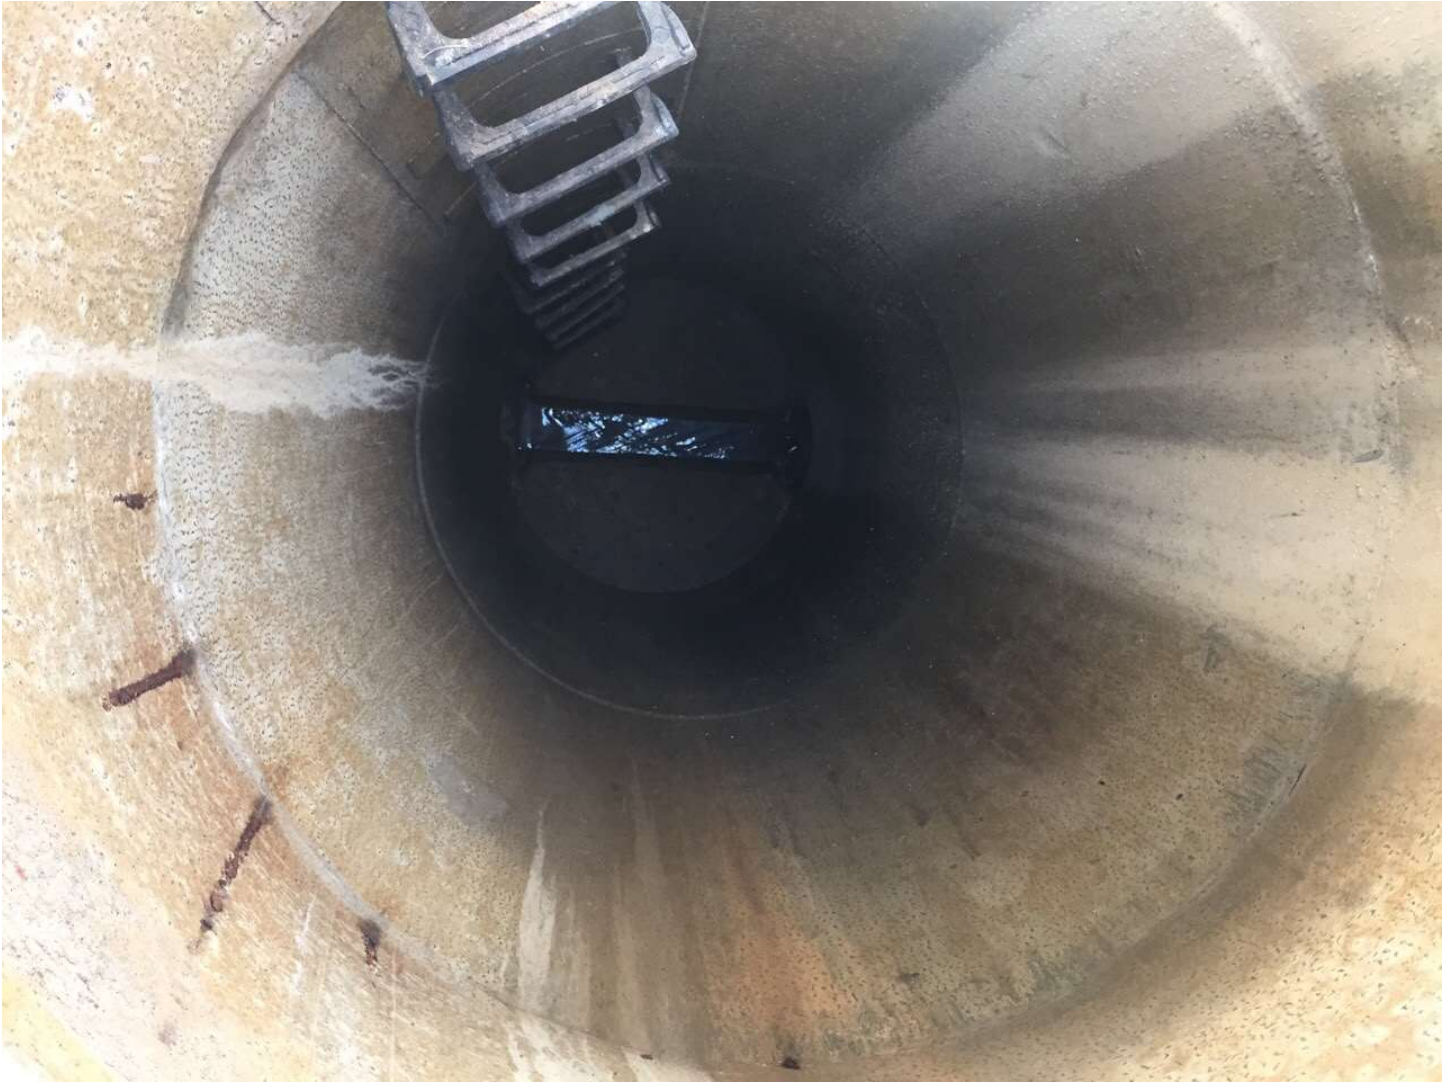
Date: 7/25/2017
Address: 25847 Lord
R.T. = 17.20'
D = 48"
Map: 78

W truss 12"
17.20'
F

E truss 12"
17.20'
F
