Manhole Inspection Form

M1-5-3-3-17-3-6

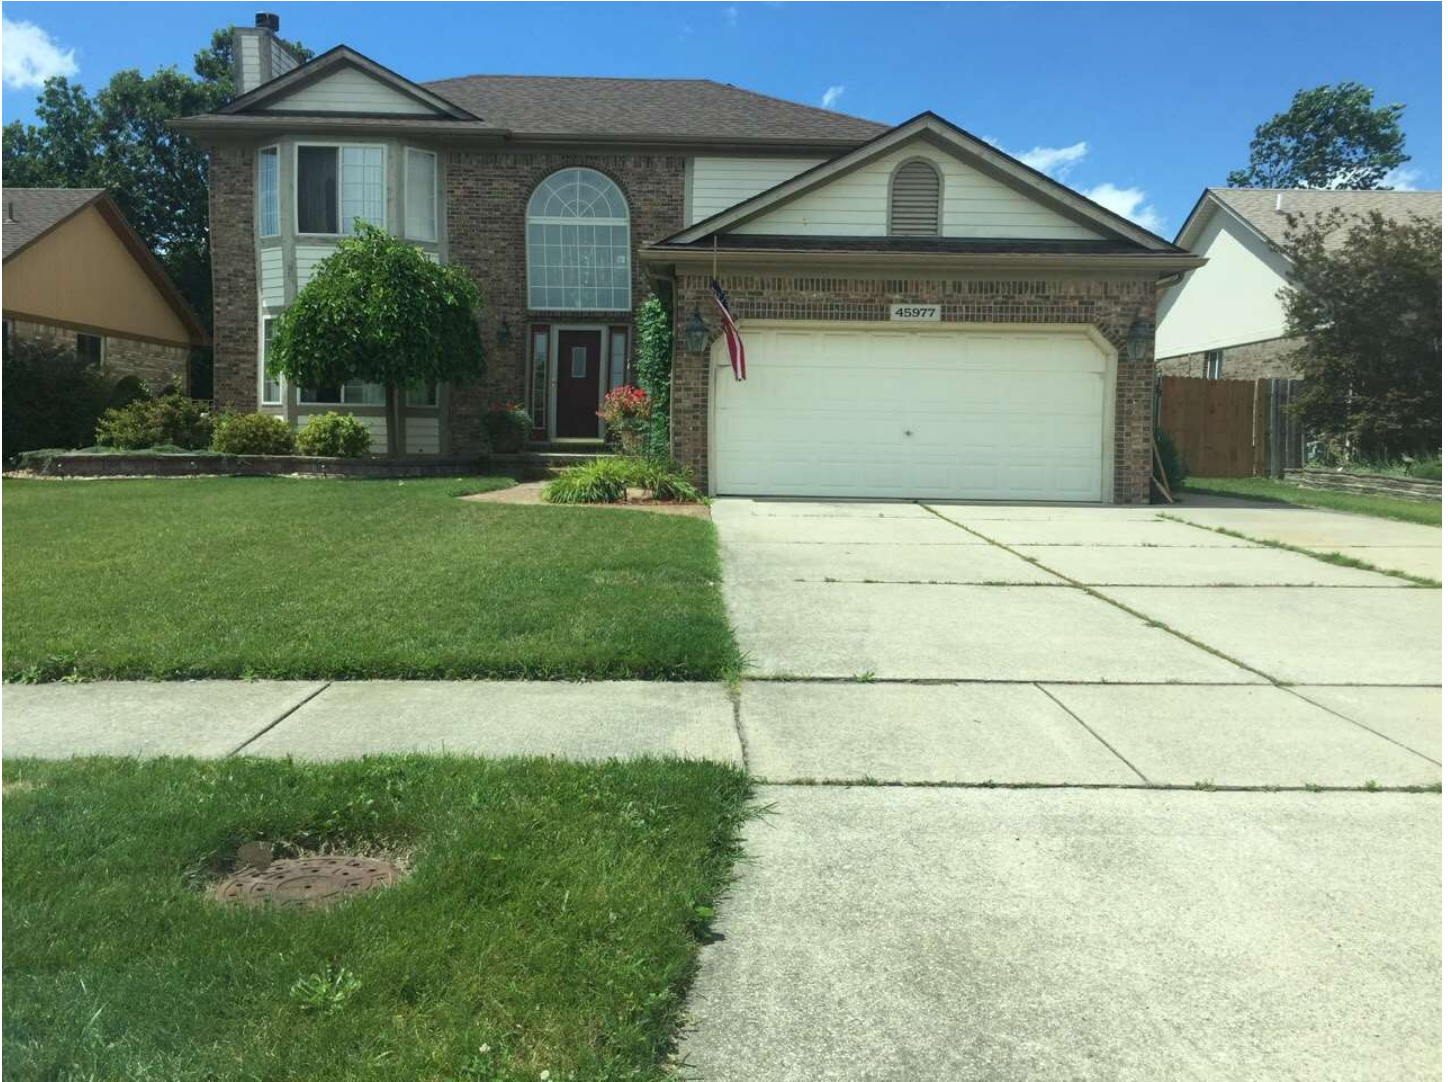
M1-5-3-3-17-3-6

Recommendation 7	<null>	Recommendation 8	<null>
Manhole Rating	2 – Failure unlikely in 20 years (Good)	Comments	Frame seal is out of place.

Pipe 6 Flow	<null>	Pipe 6 Diameter	<null>
Pipe 6 Direction	<null>	Pipe 6 Depth	<null>
Pipe 6 Material	<null>	Pipe 6 Seal Condition	<null>
Pipe 6 Drop	<null>	Pipe 6 Comments	<null>
Recommendation 1	Reset F&C w/Ext. Seal	Recommendation 2	<null>
Recommendation 3	<null>	Recommendation 4	<null>
Recommendation 5	<null>	Recommendation 6	<null>
