# Manhole Inspection Form

## M1-7-2

Manhole Number	M1-7-2	Historic Manhole Number	Pinewood 2
Year Installed	1986	Structure Type	Sanitary Manhole
Street	Pinewood	Address	47303
Elevation	592.986	Weather	Partly Cloudy
Temperature	20°	Ground Condition	Dry
Status	At Surface Grade	Location	Yard Front
Pavment Condition	<null>	Traffic	No Traffic at Location
Inspector 1	Brs	Inspector 2	Kmd
Cover Type	Ej1040a	Number of Cover Holes	Solid Cover
Catch Basin Cover	<null>	Cover Insert	No
Cover Gasket	No	Cover Grade	Cover is At Grade
Grade Dist	5	Cover Fit	Good Fit
Cover Condition	Good	Frame Condition	Good
Frame Offset	<null>	Frame Seal Condition	Fair
Frame Seal Inflow	None	Frame Riser	No
Frame Riser Height	<null>	Frame Riser Material	N/A
Manhole Diameter	48	Manhole Depth	20.4
Chimney Depth	0.6	Chimney Construction	Precast
Chimney Condition	Good	Chimney Inflow	None
Cone Shape	Eccentric	Cone Depth	30
Cone Construction	Precast	Cone Condition	Fair
Cone Inflow	None	Cone Defect Location	<null>

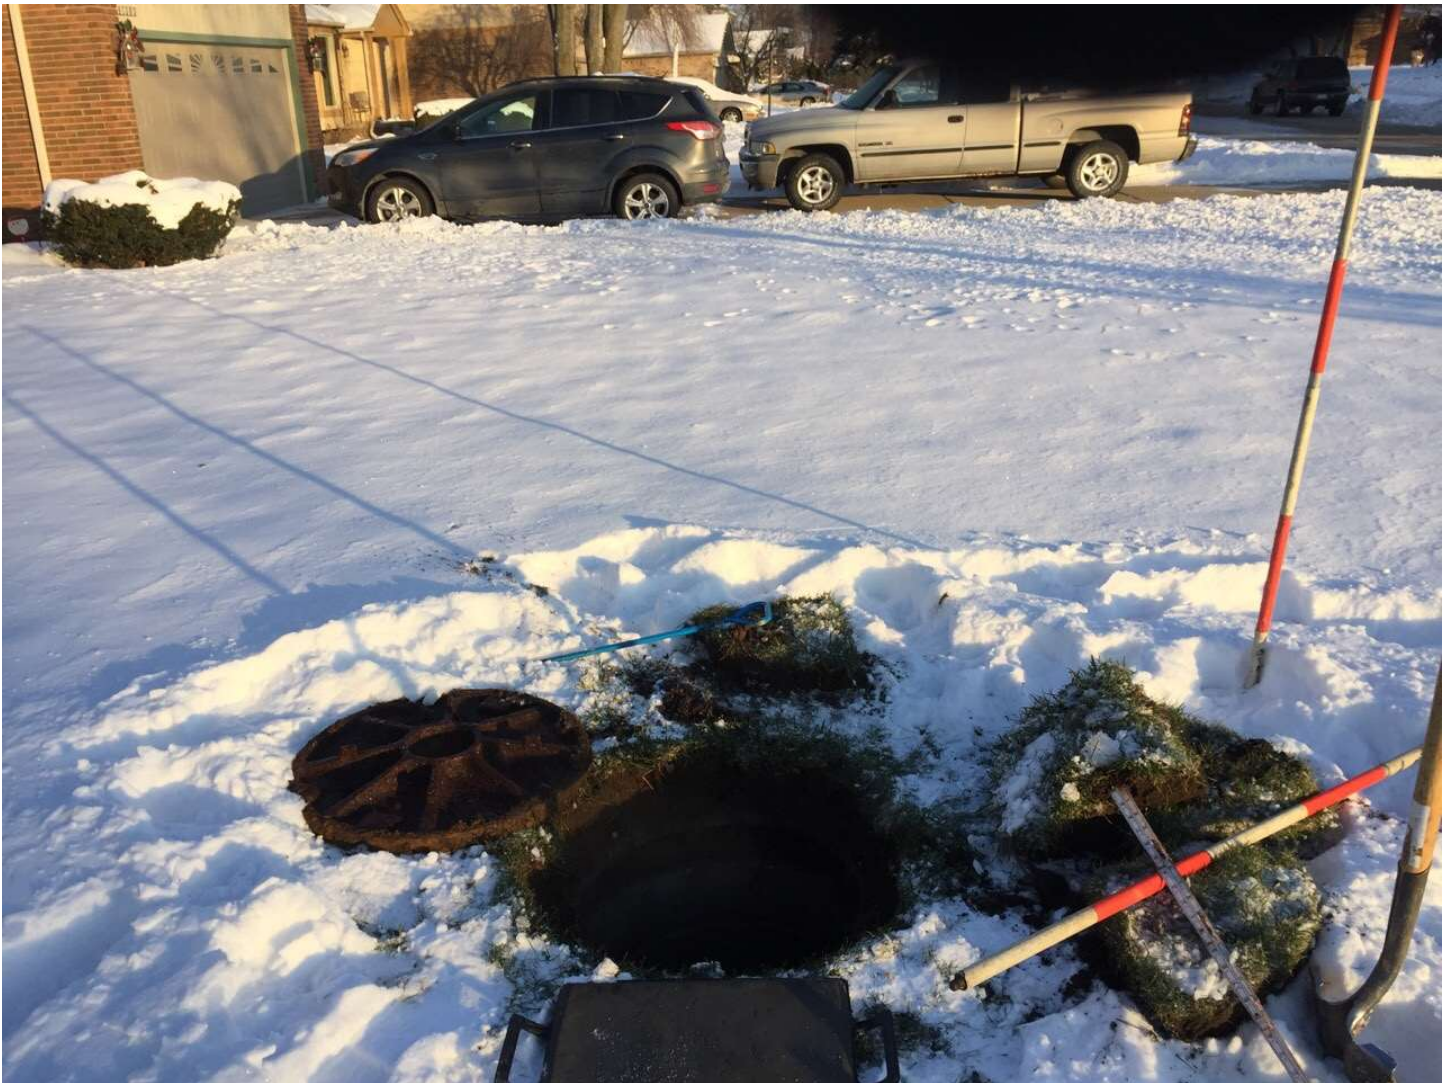
M1-7-2

Recommendation 7	<null>	Recommendation 8	<null>
Manhole Rating	2 – Failure unlikely in 20 years (Good)	Comments	Buried 5 inches deep

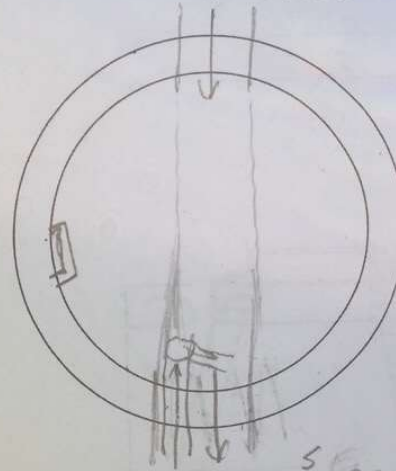
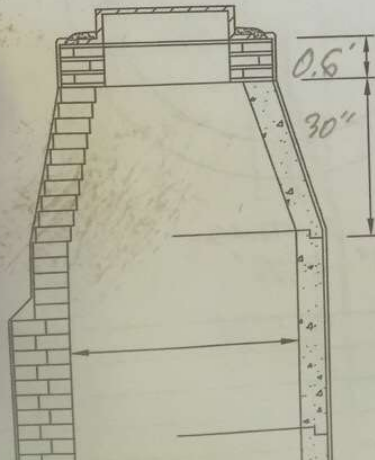
Manhole Number: M1-7-2

N Truss  
12" 20.40'

In+ 56" PVC  
Drop 6.45'  
S 20.25  
12" Truss
