Manhole Inspection Form

M1-7-6-6

ANDERSON, ECKSTEIN & STRICK, INC.
51301 Schoenherr Road, Shelby Township, Michigan 48315
Civil Engineers • Surveyors • Architects 586-726-1234

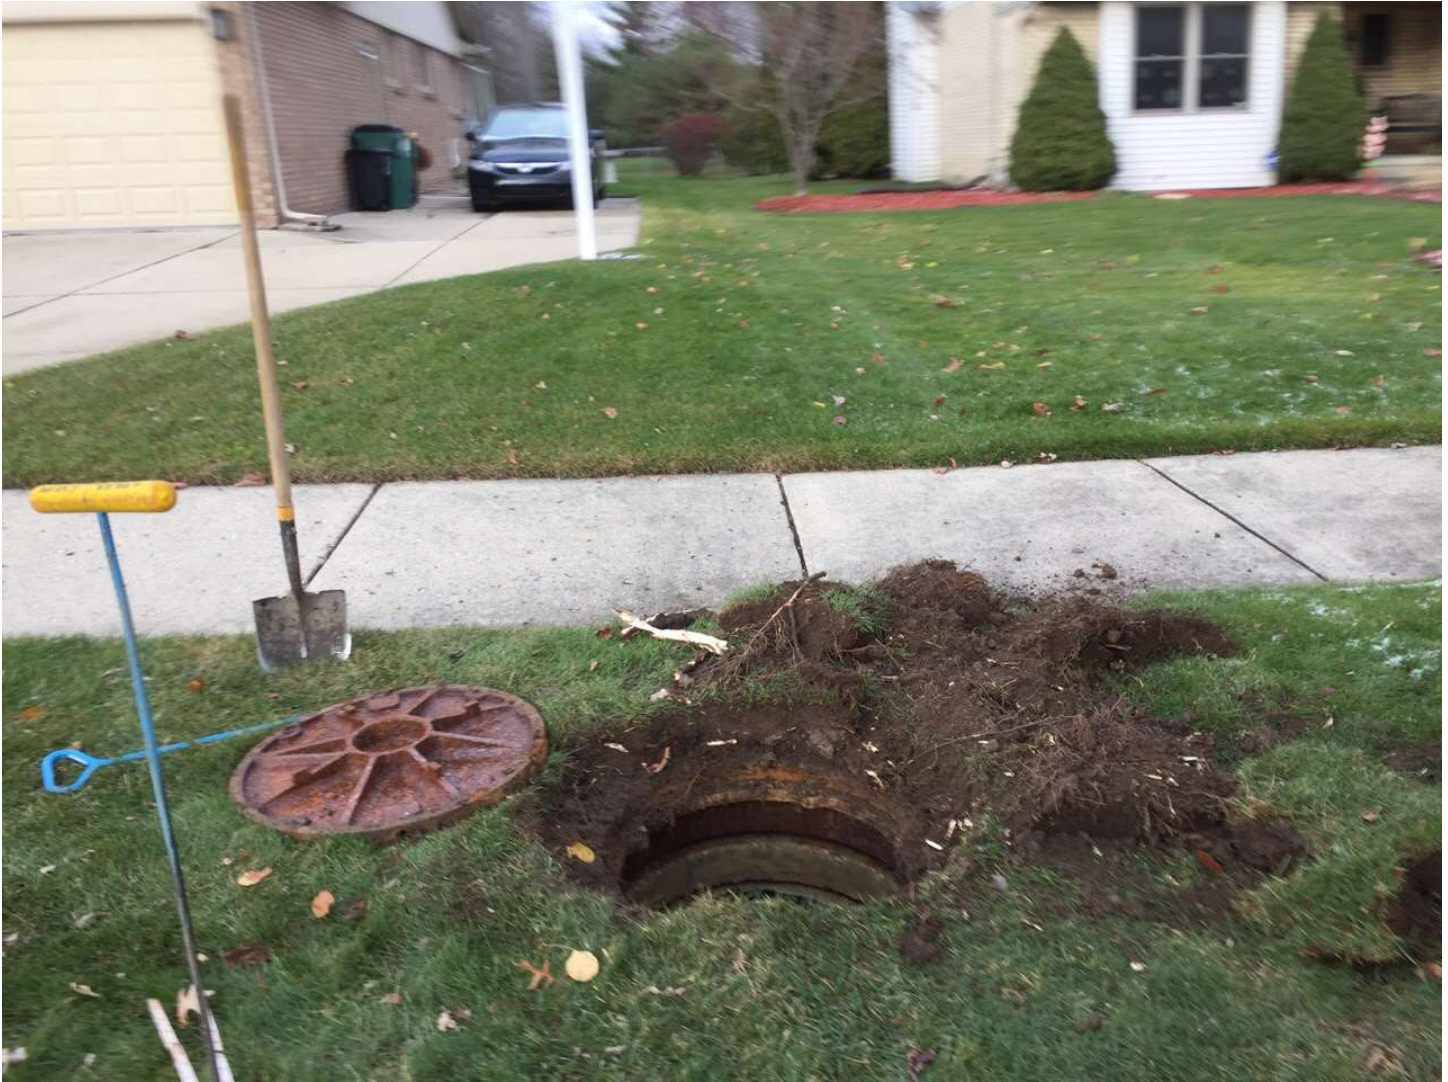
Recommendation 7	<null>	Recommendation 8	<null>
Manhole Rating	2 – Failure unlikely in 20 years (Good)	Comments	Buried 5"

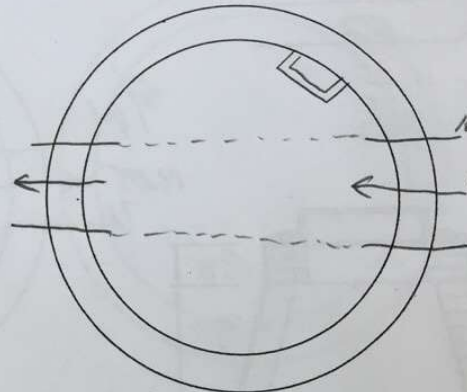
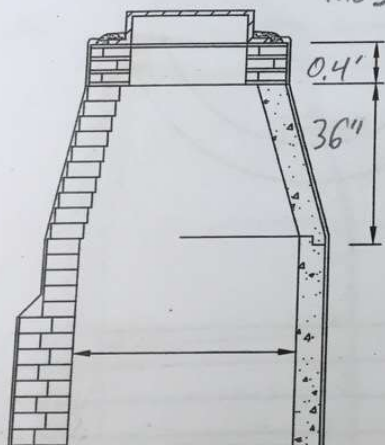
W
10" Truss
11.65 6

E
10" Truss
11.60 6
