Manhole Inspection Form

M2-16-36-P5-2WA

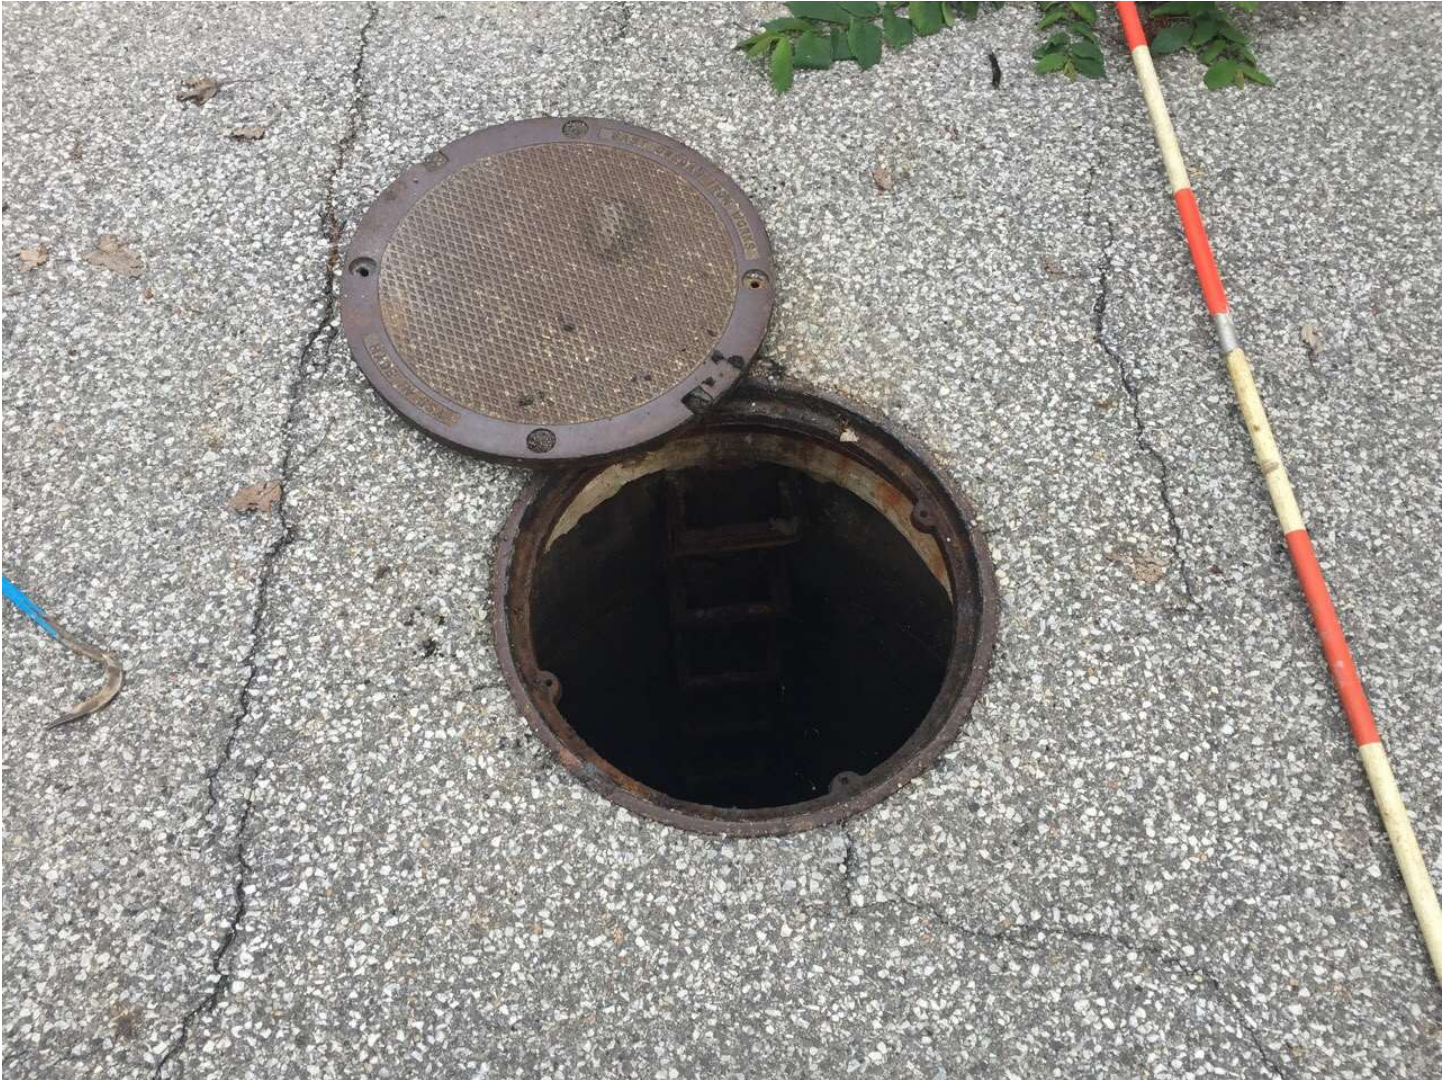
Manhole Number	M2-16-36-P5-2WA	Historic Manhole Number	Sugarbush 1C
Year Installed	1971	Structure Type	Sanitary Manhole
Street	Sugarbush	Address	48469
Elevation	587.495	Weather	Overcast
Temperature	80°	Ground Condition	Dry
Status	At Surface Grade	Location	Paved Asphalt
Pavment Condition	Fair	Traffic	Two to Three Lane Road
Inspector 1	Jef	Inspector 2	Amc
Cover Type	EJ 1040APT	Number of Cover Holes	Solid Cover
Catch Basin Cover	N/A	Cover Insert	No
Cover Gasket	No	Cover Grade	Cover is At Grade
Grade Dist	0	Cover Fit	Tight Fit
Cover Condition	Good	Frame Condition	Good
Frame Offset	<null>	Frame Seal Condition	Good
Frame Seal Inflow	None	Frame Riser	<null>
Frame Riser Height	<null>	Frame Riser Material	<null>
Manhole Diameter	48	Manhole Depth	12.55
Chimney Depth	0.6	Chimney Construction	Brick
Chimney Condition	Good	Chimney Inflow	None
Cone Shape	<null>	Cone Depth	24
Cone Construction	Precast	Cone Condition	Good
Cone Inflow	Low	Cone Defect Location	Wall/Cone Joint

Wall Construction	Precast	Wall Condition	Good
Wall Inflow	None	Wall Defect Location	Wall Joint
Wall Defect Location 2	<null>	Wall Defect Location 3	<null>
Wall Defect Location 4	<null>	Wall Defect Location 5	<null>
Bench Construction	Poured	Bench Condition	Good
Bench Inflow	None	Channel Construction	Poured
Channel Condition	Good	Channel Inflow	None
Channel Hydraulics	Good	Channel Exposure	Fully

Pipe 6 Flow	<null>	Pipe 6 Diameter	<null>
Pipe 6 Direction	<null>	Pipe 6 Depth	<null>
Pipe 6 Material	<null>	Pipe 6 Seal Condition	<null>
Pipe 6 Drop	<null>	Pipe 6 Comments	<null>
Recommendation 1	Seal Wall Joints	Recommendation 2	<null>
Recommendation 3	<null>	Recommendation 4	<null>
Recommendation 5	<null>	Recommendation 6	<null>
