Manhole Inspection Form

M1-5-3-3-8-5

Community: Chesterfield

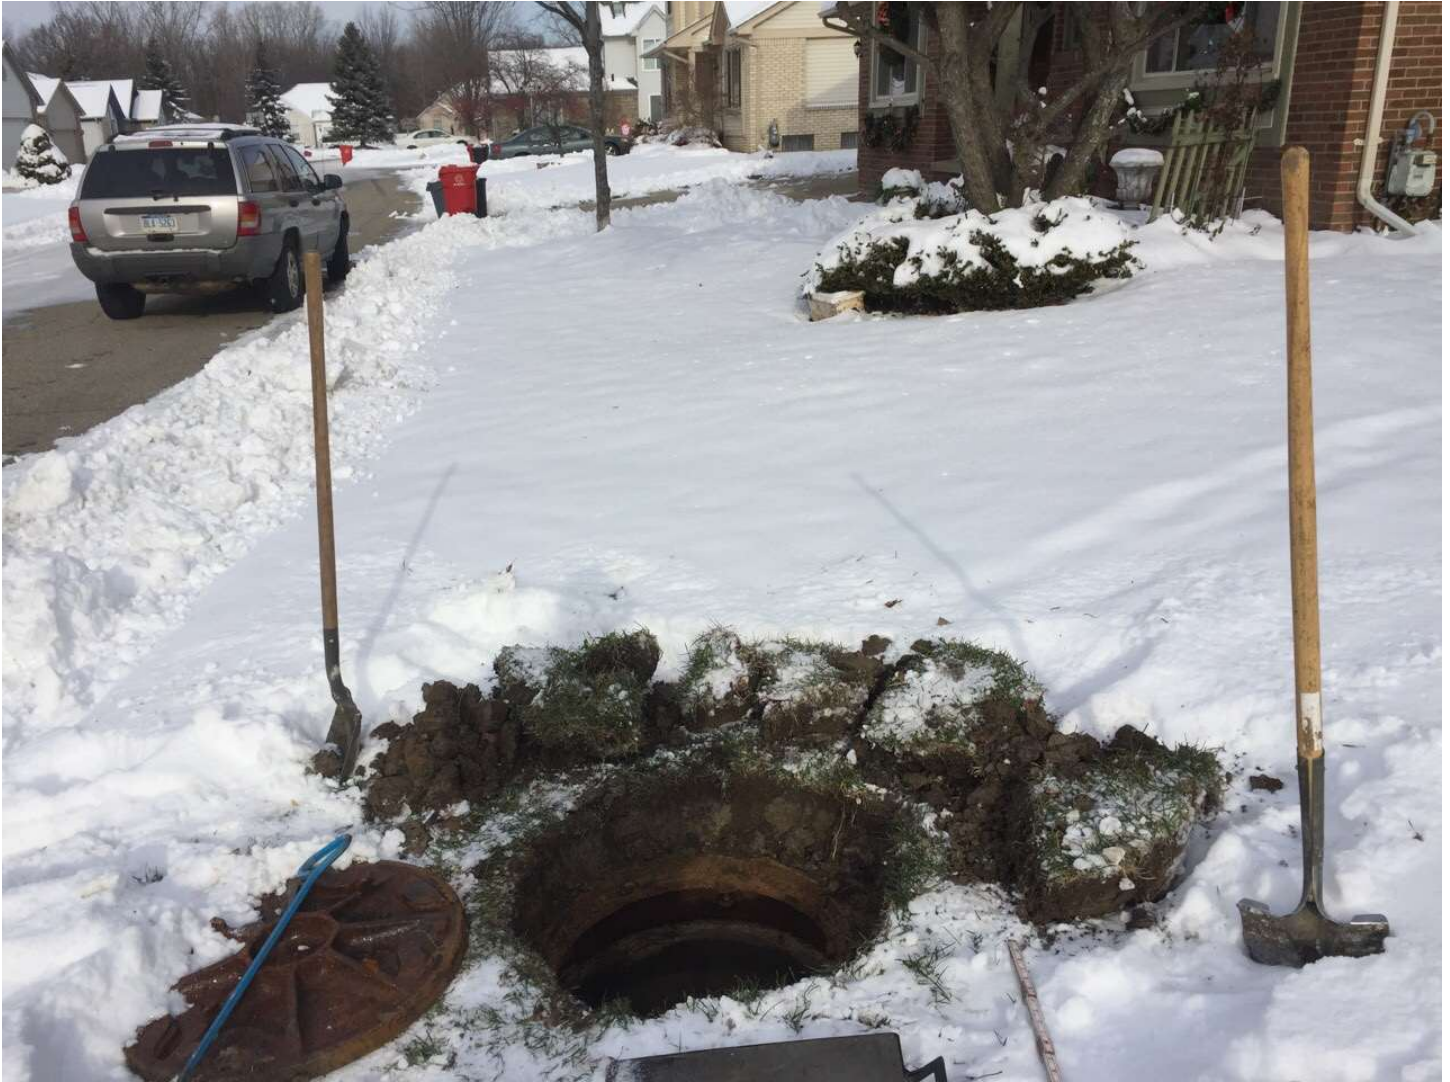
Manhole Number	M1-5-3-3-8-5	Historic Manhole Number	Greenbriar 5
Year Installed	1992	Structure Type	Sanitary Manhole
Street	Greenbriar	Address	46562
Elevation	591.117	Weather	Overcast
Temperature	20°	Ground Condition	Wet
Status	At Surface Grade	Location	Yard Front
Pavment Condition	N/A	Traffic	No Traffic at Location
Inspector 1	Brs	Inspector 2	Kmd
Cover Type	Ej1040a	Number of Cover Holes	Solid Cover
Catch Basin Cover	N/A	Cover Insert	No
Cover Gasket	No	Cover Grade	Cover is Below Grade
Grade Dist	6	Cover Fit	Good Fit
Cover Condition	Good	Frame Condition	Good
Frame Offset	<null>	Frame Seal Condition	Fair
Frame Seal Inflow	None	Frame Riser	No
Frame Riser Height	<null>	Frame Riser Material	N/A
Manhole Diameter	48	Manhole Depth	8.6
Chimney Depth	<null>	Chimney Construction	None
Chimney Condition	<null>	Chimney Inflow	<null>
Cone Shape	Eccentric	Cone Depth	38
Cone Construction	Precast	Cone Condition	Good
Cone Inflow	Low	Cone Defect Location	Wall/Cone Joint

Recommendation 7	<null>	Recommendation 8	<null>
Manhole Rating	2 – Failure unlikely in 20 years (Good)	Comments	Buried 6"

Pipe 6 Flow	<null>	Pipe 6 Diameter	<null>
Pipe 6 Direction	<null>	Pipe 6 Depth	<null>
Pipe 6 Material	<null>	Pipe 6 Seal Condition	<null>
Pipe 6 Drop	<null>	Pipe 6 Comments	<null>
Recommendation 1	Raise	Recommendation 2	<null>
Recommendation 3	<null>	Recommendation 4	<null>
Recommendation 5	<null>	Recommendation 6	<null>
