Manhole Inspection Form

M1-7-6-6

ANDERSON, ECKSTEIN & STRICK, INC.
51301 Schoenherr Road, Shelby Township, Michigan 48315
Civil Engineers • Surveyors • Architects 586-726-1234

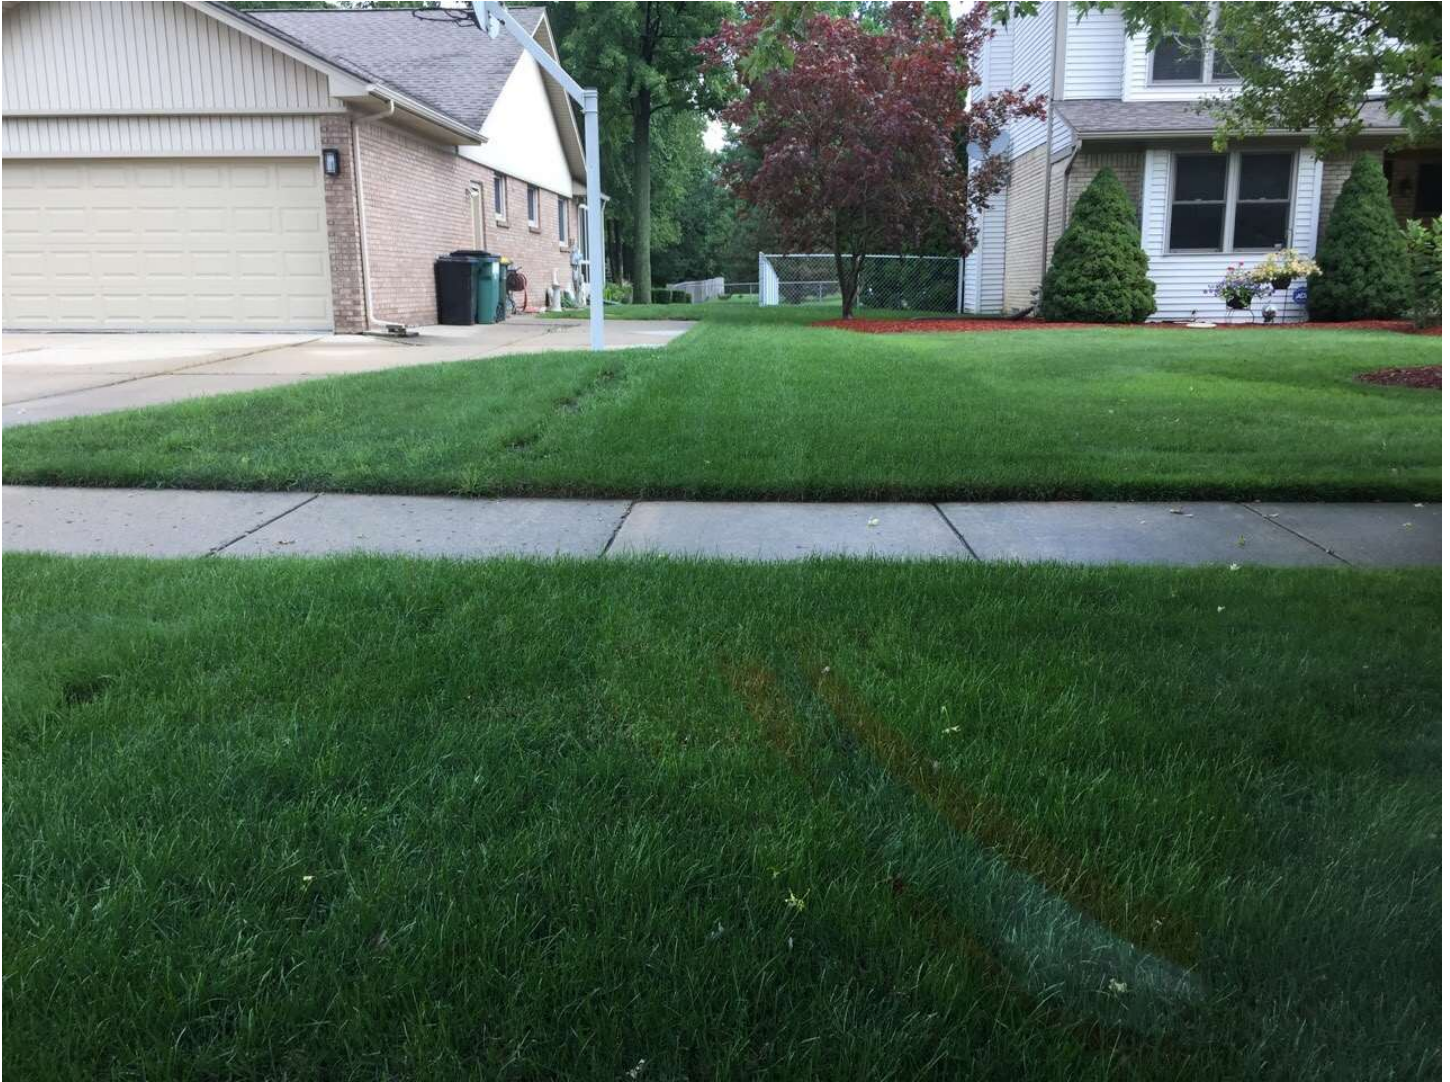
M1-7-6-6

Recommendation 7	<null>	Recommendation 8	<null>
Manhole Rating	2 – Failure unlikely in 20 years (Good)	Comments	Buried 5"
